High Strength Liner Studs for Gas Turbine HRSGs

New! High Strength Liner Stud For Severe Service

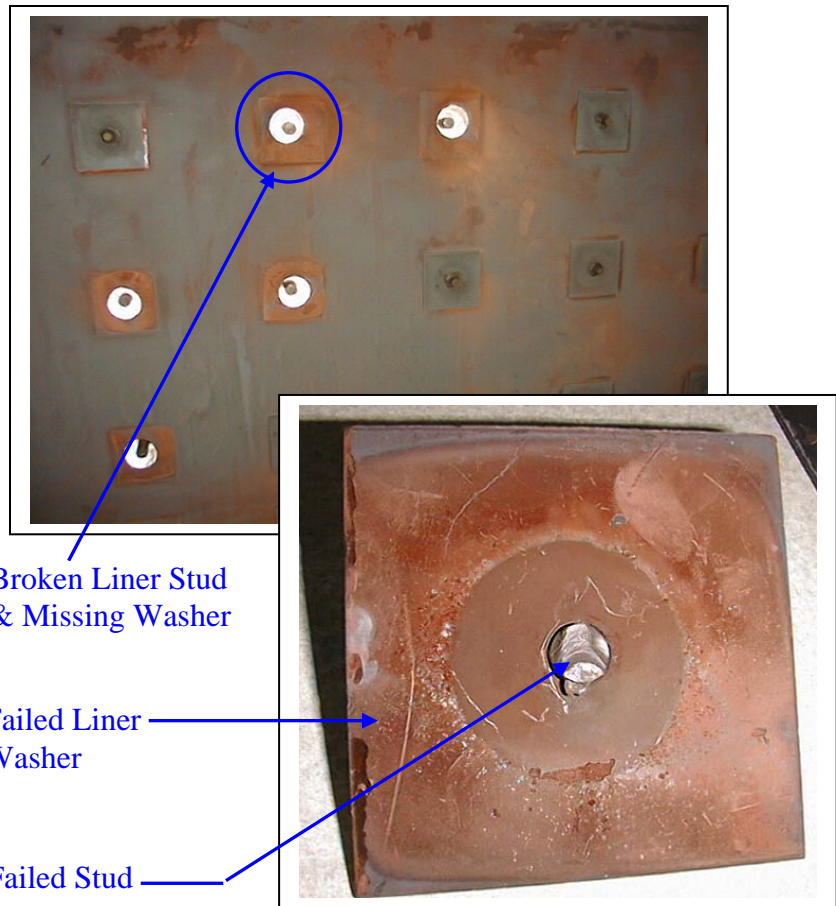
HRST has seen a number of liner stud failures in inlet ducts, near the gas turbine connection. With some liner systems, turbulence in the exhaust causes liner plates to vibrate and studs fail at the “shoulder” where the diameter reduces. This problem occurs most frequently with LM6000 and W501FD2 gas turbine models, due to particularly turbulent exhaust.

Broken Studs in an HRSG Inlet Duct

We have designed a replacement stud specifically for this problem. Careful analysis of the failure mechanism is first recommended to verify the root cause of the problem.
