HEAT RECOVERY SYSTEM TECHNOLOGY

Sidewall Penetration Seals

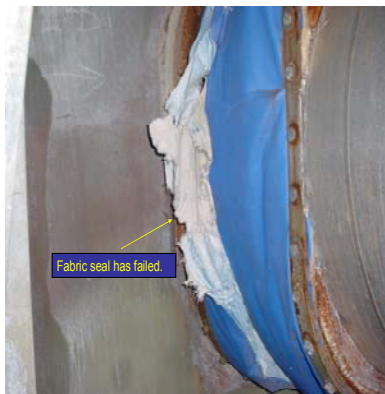
1. No insulation on the inside of a lower header area exposed to >1000 °F gas and steam temperatures leads to faster deterioration of fabric or metal bellows seals.
2. Failure of fabric or metal bellows can cause casing hot spots.
3. Failure of fabric or metal bellows can cause personnel safety risks.

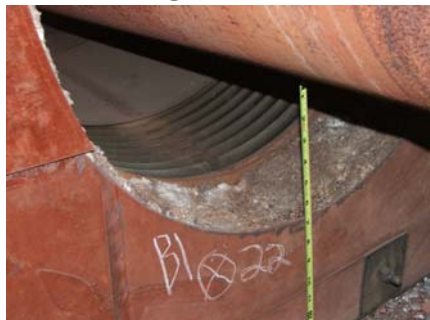
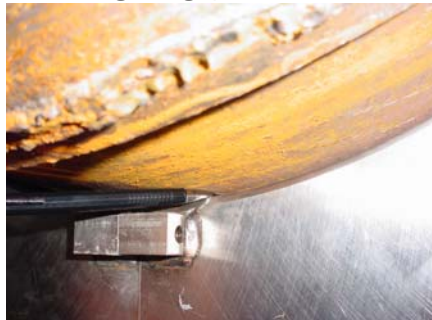
From this 7" gap

to a designed gap for movement!

Sidewall Casing Penetration Seal was unveiled as a new HRST product in late 2004. These seals are vertical for side wall casing surfaces. They provide a long term sealing solution to large piping penetrations with large lateral movements commonly found in Foster Wheeler, Alstom, and Vogt designs.

This 'patent pending' design includes no flexible metal or fabric and is custom designed for each application. A seal ring with a machined tolerance and three independent layers of insulation provide the sealing. Do you have gang seals? No problem! We can retrofit gang seals. Do you have interferences from piping or structural members? No problem! Our seals are only 8" from the casing to the containment housing. These seals are available only from HRST, Inc. as we have applied for and received patent pending status!
